Anguilla Wreck Dive Site Baseline Assessment

Department of Fisheries and Marine Resources

Draft Report (2017)

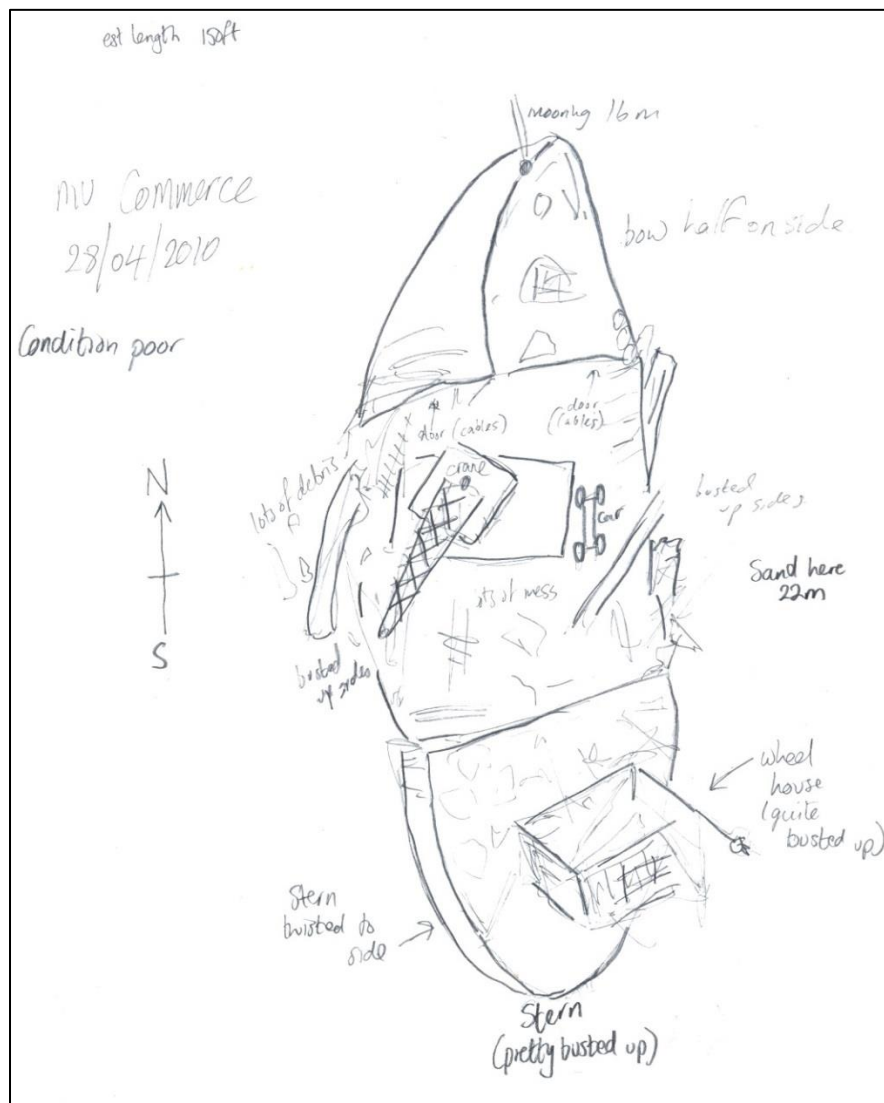
Figure 2: Hand-drawn sketch of MV Commerce from April 2010

Wreck Name	Commerce
Location	North of Flat Cap Point - 18°14.470 N 63°04.631 W
Estimated Length	100 ft (30 m)
Depth	75 ft (22 m)
Condition	Poor

Details: Originally owned by Clement Daniels and sunk c.1985 as an artificial reef after being decommissioned (no further details known). Stern is tilted to the side and a bit twisted and broken up. Mid-section completely scattered aside from the crane. Lots of debris including very degraded car. Bow is on side but relatively intact. Fish abundance: low.

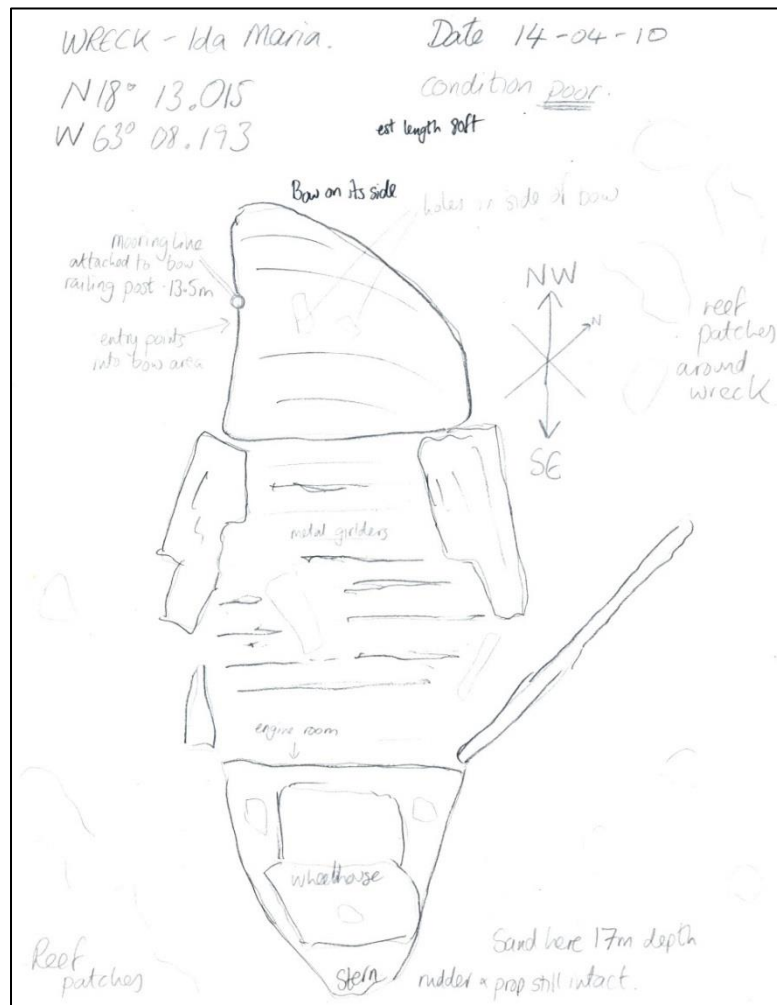
Figure 3: Hand-drawn sketch of MV Ida Maria from April 2010

Wreck Name	Ida Maria
Location	Near Sandy Island - 18°13.015 N 63°08.193 W
Estimated Length	80 ft (25 m)
Depth	60 ft (18 m)
Condition	Poor

Details: Originally owned by Freddy Hughes and sunk c.1985 as an artificial reef after being decommissioned (no further details known). Reportedly sunk in 1985 (no further details known). Bow is fully detached and laying on its side, and mid-section is completely broken up. Not much debris. Stern is relatively complete. Moderate fish density considering the poor condition of the wreck. Some Barracuda swimming around and schools of chromis (etc), but in general fish abundance: low.

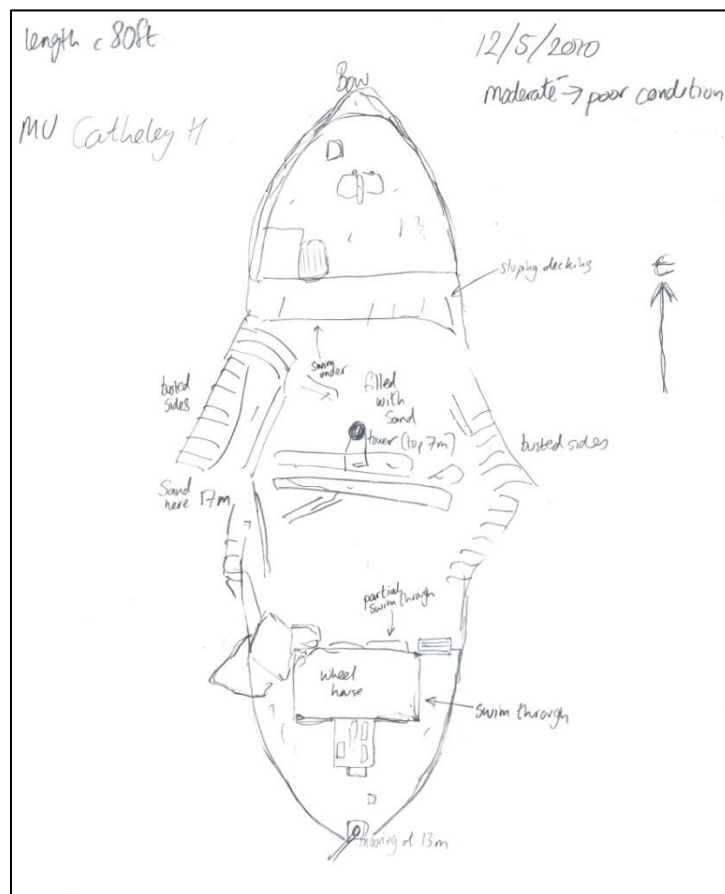
Figure 4: Hand-drawn sketch of MV Catheley H from May 2010

Wreck Name	Catheley H
Location	NE of Road Point - 18°12.824 N 63°05.598 W
Estimated Length	80 ft (25 m)
Depth	60 ft (18 m)
Condition	Moderate to Poor

Details: Rumored to have been built in 1918 by the British. Originally owned by Carl Gumbs and was being prepared for intentional sinking in 1995 when a fire broke out below deck and sunk it on its anchorage prematurely. Apparently garbage and debris was being burned when a crew member sustained a leg injury and everyone left the vessel to tend the wound. The next morning the vessel had sunk. This is why the wreck looks older when compared to those sank in 1990. Sometimes alternative spellings are used such as Katheley H, Kathly H or Cathely H. Stern is intact, but mid-section twisted and broken up. No debris, but filled with sand and many discarded conch shells, with mid-deck upright still intact (7m). Bow is complete and upright, with twisted hull sections reminiscent of a Humpback Whale. Fish abundance: moderate.

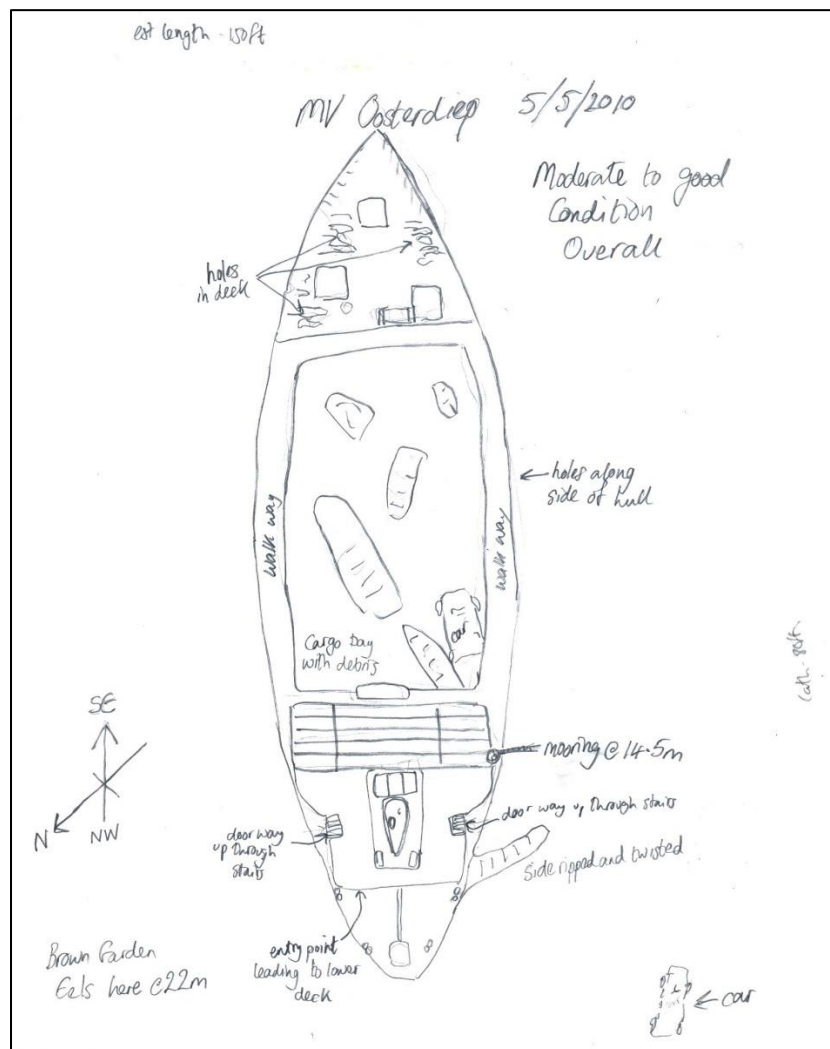
Figure 5: Hand-drawn sketch of MV Oosterdiep from May 2010

Wreck Name	Oosterdiep
Location	West of Meads Point - 18°11.521 N 63°09.473 W
Estimated Length	130 ft (40 m)
Depth	75 ft (22 m)
Condition	Good

Details: Sunk during the 1990 Road Bay clean-up operation (see newspaper clipping in appendix). Wreck is almost intact, although mid-section gunwale of starboard side is broken off and hull edge is degrading. A rogue car is located off the starboard side of the stern. Often a lot of Barracuda swimming around over this wreck, and has a tendency to have better water visibility than most of the others. Fish abundance: high.

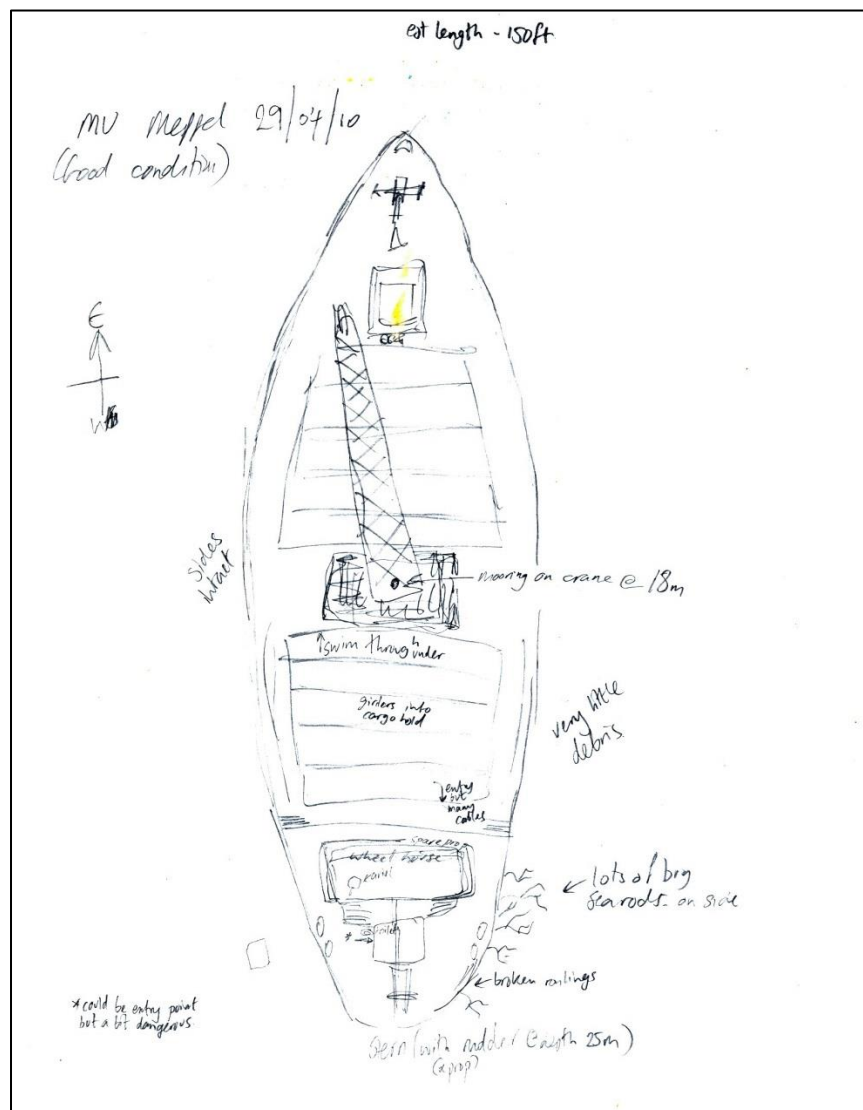
Figure 6: Hand-drawn sketch of MV Meppel from April 2010

Condition Good

Details: Sunk during the 1990 Road Bay clean-up operation (see newspaper clipping in appendix). Fully intact with amazing swim through hull cargo area under crane assembly. Very little debris. Fish abundance: high – mainly due to schooling grunts.

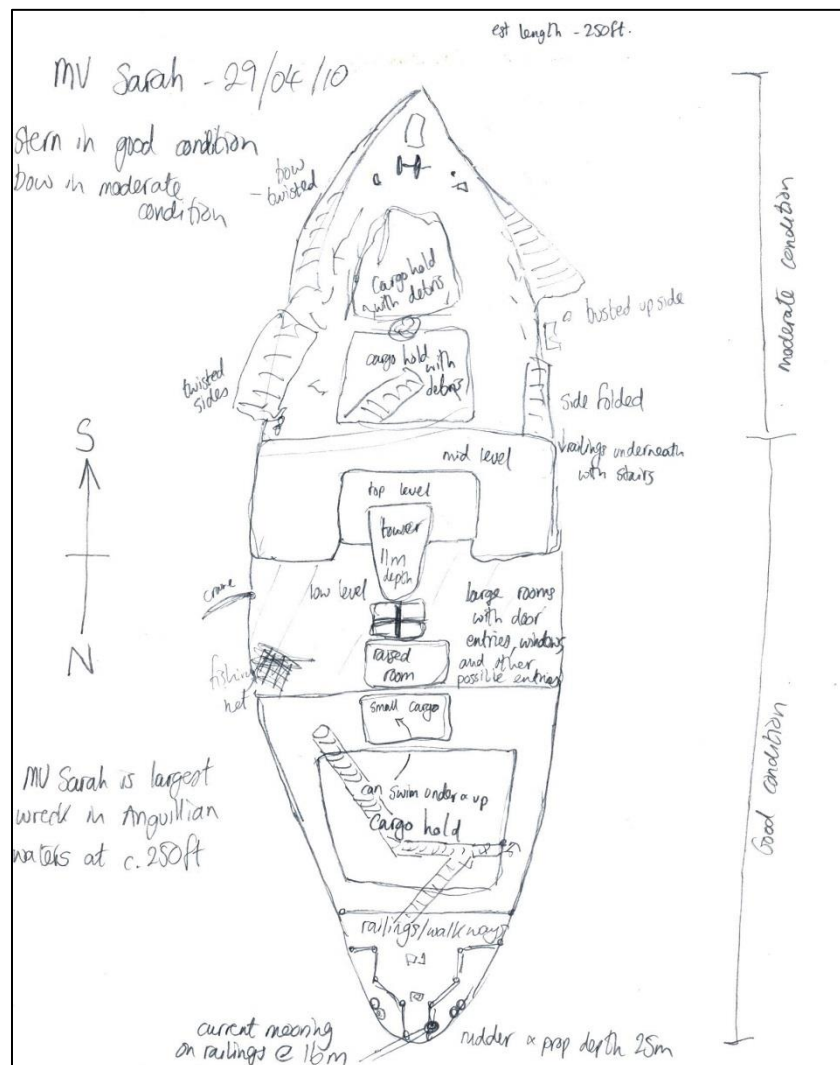
Figure 8: Hand-drawn sketch of MV Sarah from April 2010

Condition Good

Details: Sunk during the 1990 Road Bay clean-up operation (see newspaper clipping in appendix). Almost intact, aside from parts of hull broken and a little twisted near the bow. Being the largest of wrecks, with amazing swim through options and lots to explore, this is often rated as the best dive to be done in Anguilla. Fish abundance: very high.

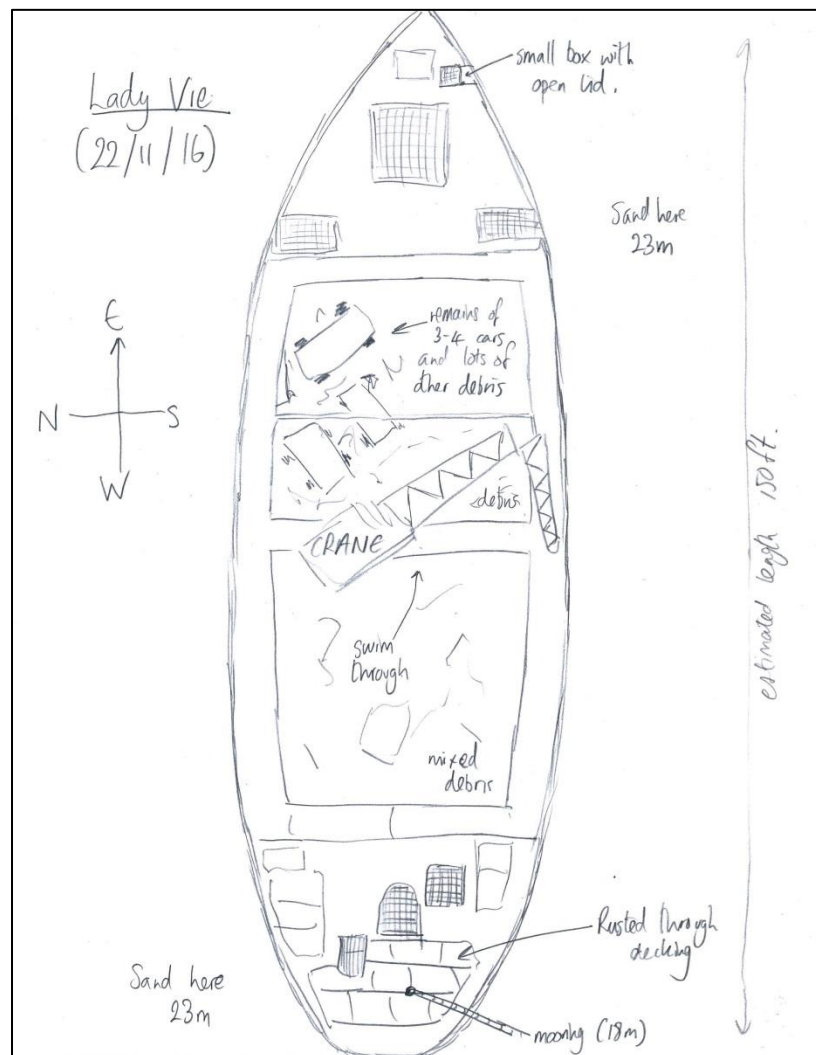
Figure 7: Hand-drawn sketch of MV Lady Vie from November 2016 (location was lost at the time the last sketches for the other wrecks were made).

Wreck Name	Lady Vie
Location	Long Reef 18°15.592 N 63°06.697 W
Estimated Length	130 ft (40 m)
Depth	75 ft (23 m)
Condition	Good

Details: Sunk during the 1990 Road Bay clean-up operation (see newspaper clipping in appendix). Fully intact although crane is snapped and bent at right angle. Good swim through under crane and into debris field of 3-4 degraded cars and other bits. Schooling fish, including frequent schools of large jacks. Fish abundance: moderate.

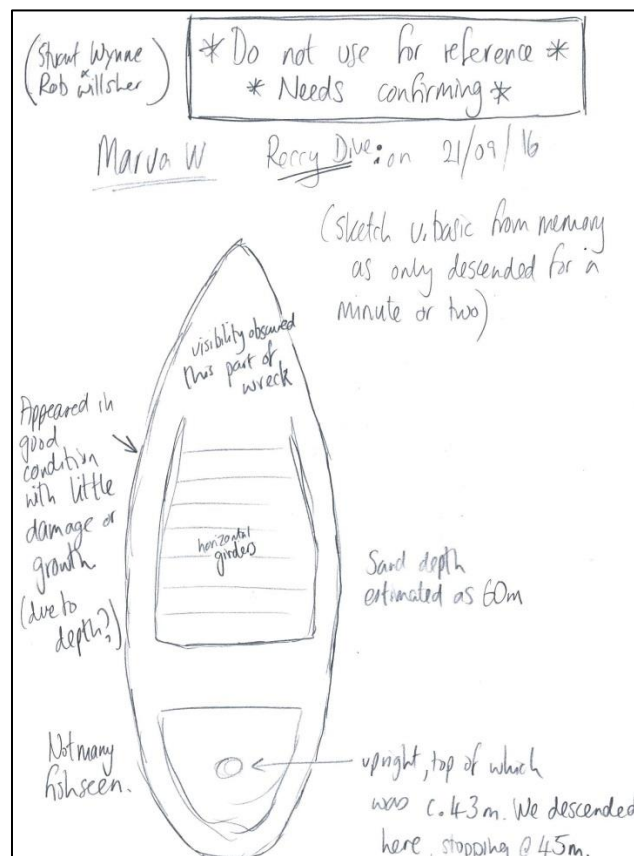
Figure 9: Hand-drawn 'memory sketch' of MV Marva W from September 2016

Wreck Name	Marva W
Location	West of Sandy Island - 18°12.514 N 63°08.727 W
Estimated Length	130 ft (40 m)
Sea Floor Depth	200 ft (60 m)
Condition	Good

Details: It is thought that this vessel was sunk during the 1990 Road Bay clean-up operation. However, this is not mentioned in the newspaper clipping (appendix), but this may be as when it was sunk it reportedly drifted down off course and disappeared into the deep channel near Authors Deep dive site. This depth was confirmed when the wreck was relocated during 2016 through new bathymetry work and dived by Stuart Wynne and Rob Willsher. It sits in 60 m of water, but it can be seen from 30 m when good visibility and has an upright at 45m. Thus it does have potential as a technical dive site. The vessel looked completely intact, and almost pristine with little damage or marine growth and few fish. Lies orientated almost exactly east to west (bow to stern). This will all need confirming on a later when dive site potential is fully assessed.
