Anguilla Fisheries and Marine Resources Research Bulletin

The Anguilla Beach Monitoring Program Report 1992-2014: Temporal analysis of twenty two years of monitoring data

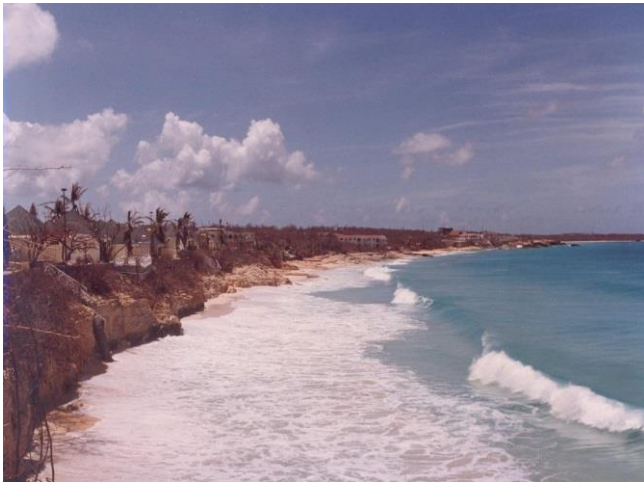
This beach was one of the most notoriously eroded in Anguilla during Hurricane Luis in 1995 and Hurricane Lenny in 1999 (Plate 1), especially along its eastern end. Extensive bedrock was exposed and the coastline retreated inland. Much of the material lost on the western end has now returned, although the eastern stretch can still be problematic. The central and western ends of Barnes Bay were originally where beachfront development was concentrated (small villas and a restaurant), and the original locations of two early monitoring sites started in 1994. Reference point losses led to one of these points being discontinued, leaving only BM04. In 2011 a new point was added (BM05). The relatively recently completed Viceroy development down the eastern end has been artificially nourishing the beach via an offshore dredger (in 2015) with large boulders in the form of small offshore breakwaters in an attempt to retain the new sand (Plate 2). For this reason two subsequent monitoring sites (BM50-51) were established in this area early in 2013.

Plates 1 (left) Looking westward across Barnes Bay during heavy storm swells following a major hurricane event in the 1990's (thought to be Hurricane Luis in 1995 but image is undated). Photograph courtesy of DFMR archives.

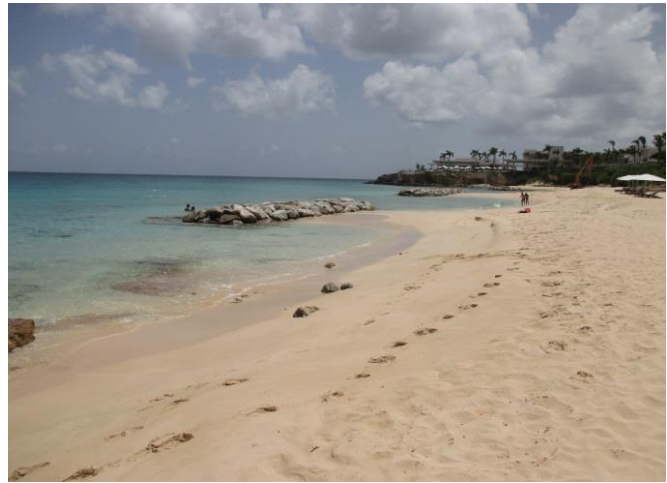
Plate 2 (right) Looking eastward across Barnes Bay in 2015 following significant beach nourishing and construction of small breakwaters. It should be noted that before this work the beach had recovered from the erosion events in the 1990's, but the new Viceroy development (renamed Four Seasons at the time of writing) desired a wider beach. Photograph courtesy of Dr. G. Cambers.

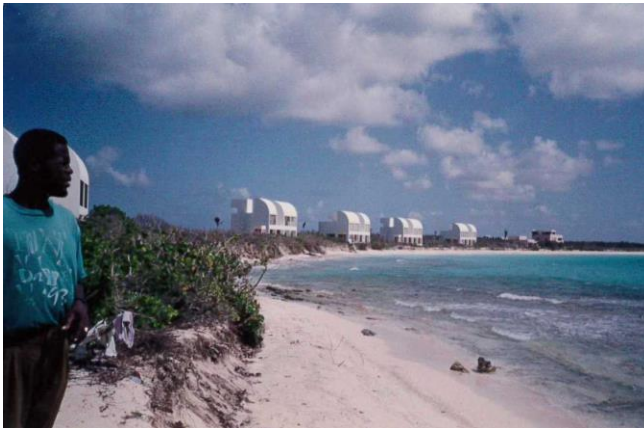
Plate 3 (left) Looking east across Shoal Bay West following Hurricane Luis in 1995. Photograph courtesy of Dr. G. Cambers.

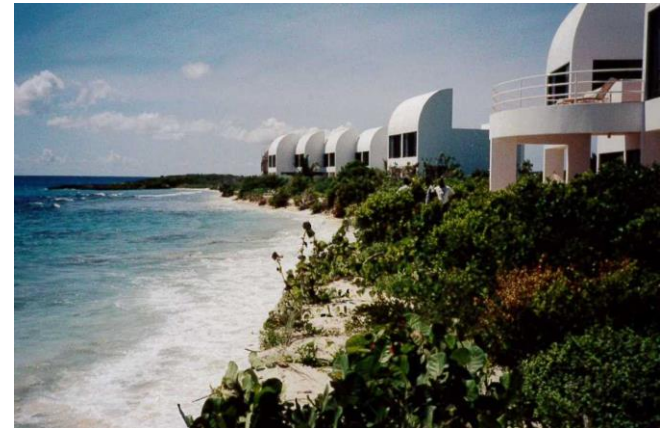
Plate 4 (right) Looking west across Shoal Bay West following an erosion event in 1997. Photograph courtesy of Dr. G. Cambers.

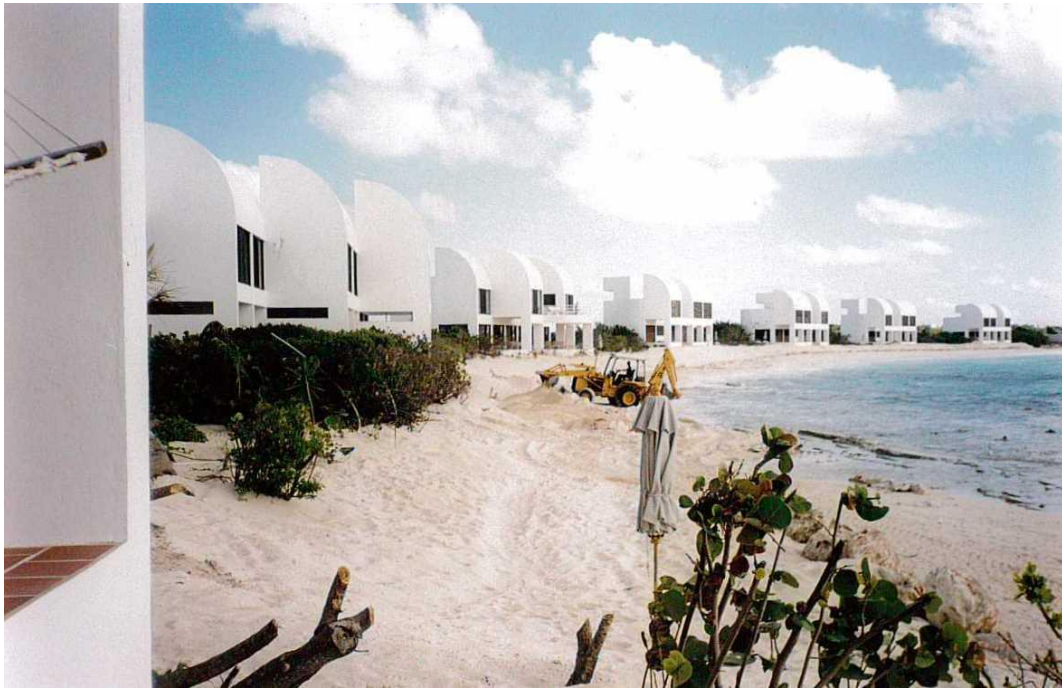
Plate 5 Looking east across Shoal Bay West in January 2000 following Hurricane Lenny in November 1999. The extent of beach nourishment that took place is not known and may have only been minimal. Photograph courtesy of Dr. G. Cambers.

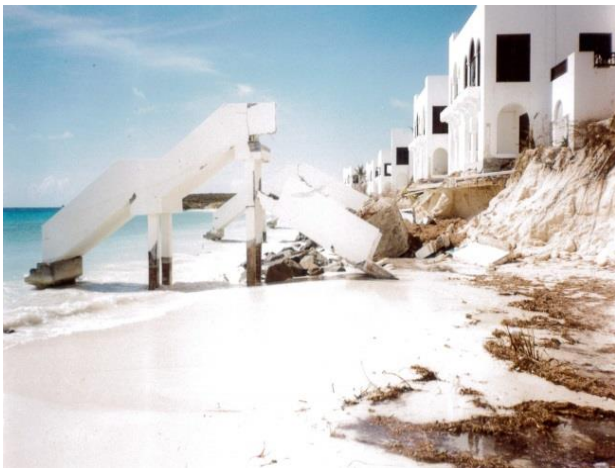
Plate 6 (left) Severe beach erosion at Maundays Bay following Hurricane Lenny in 1999. Much of the beach was washed away and villas undermined, leaving their access stairs as floating ‘islands’ in the wash zone. Photograph courtesy of Dr. G. Cambers.

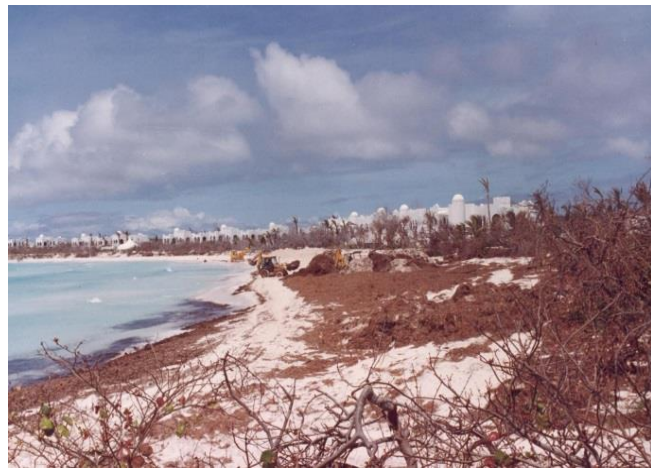
This beach has undergone significant beach nourishment programs by the management of Cap Juluca Hotel, following damage by hurricanes (Plate 7). This is illustrated in Figure 8, which also depicts the difference in regime that occurs on the western end of the beach compared with that on the eastern end. Reports and photographic evidence shows significant damage here following Hurricane Luis in 1995, although beach monitoring did not start here until after this event. In the western end, erosion continued after this storm, which led to the first beach nourishment. Sand was dredged from offshore and put along the shore line, combined with rebuilding and replanting the dune slope to increase the hotels aesthetic appearance. Between November 1995 and February 1996 a total of 40,000 cubic yards of sand were dredged from the bay and placed on the beach (Cambers, pers. comm.). In 1998 Hurricane Georges submerged the whole beach and a further 30,000 cubic yards of sand were dredged from the bay and placed on shore. This material was again lost when Hurricane Lenny hit in 1999, causing massive erosion leading to the undermining of the villa developments and many of their villa stair cases left as ‘islands’ unconnected to the buildings (Plate 6). Further beach nourishment, the construction of a major vertical sea wall in front of the villas, and replanting of vegetation restored the area by September 2000, and led to a period of relative stability until Hurricane Omar in 2008. Once again beach nourishment, this time via sand from Barbuda as well as offshore dredging, replenished the beach until Hurricane Earl in 2010 removed it again. Although these events can also be seen in the eastern profile, changes there were less severe and stability more prevalent. The evidence over the past 20 years indicates that although the beach can be restored via costly beach nourishment measures and a level of stability achieved, this is only a temporary solution until the next hurricane arrives.

Plate 7 (right) Beach nourishment taking place at Maundays Bay following one of the 1990’s hurricane events. Photograph courtesy of DFMR archives.

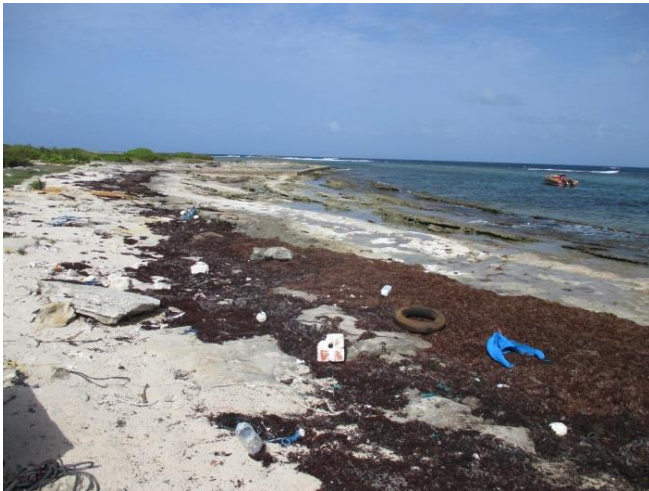
Plate 9 (left) Remains of beach at Sile Bay in 2015 following sand mining here back in the 1980's. Photograph courtesy of Dr. G. Cambers.

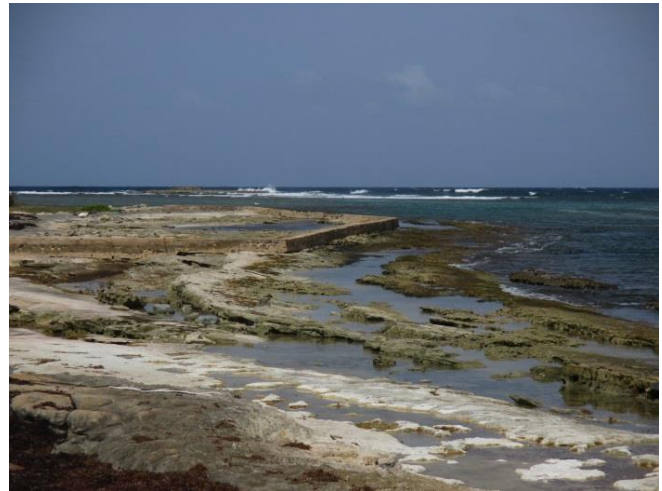
Plate 10 (right) Small retaining wall (also in top of plate 9) built in the 1990's in an attempt to halt beach erosion and retain remaining sand. Photograph courtesy of Dr. G. Cambers.

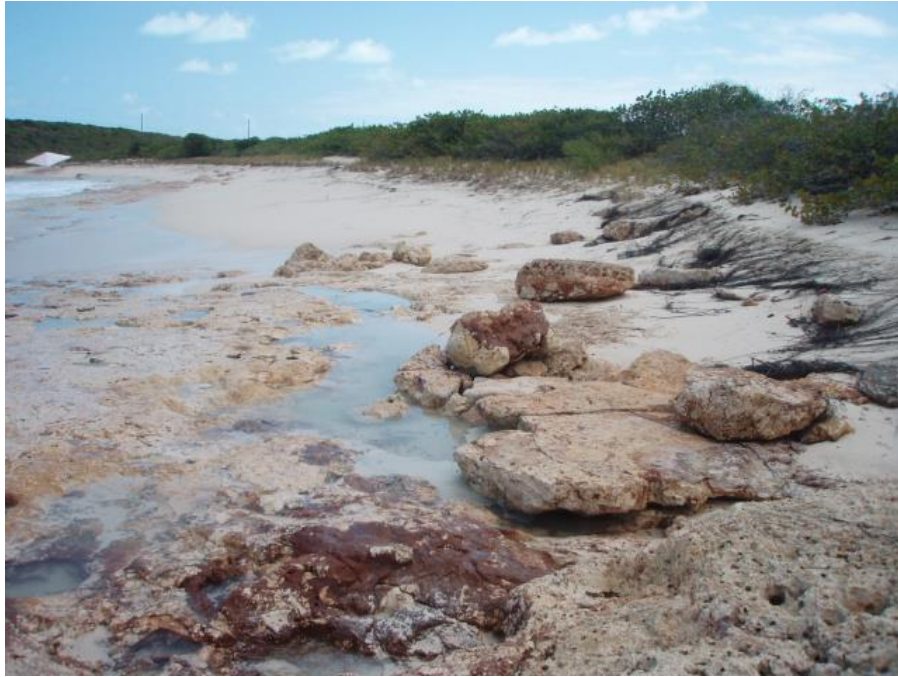
Plate 11 Captains Bay following some particularly strong ground seas in March 2008. Interestingly this event occurred prior to Hurricane Omar later that year, and may have been the reason such severe erosion occurred during the storm and also why it continued on into subsequent years. Photograph courtesy of DFMR archives.

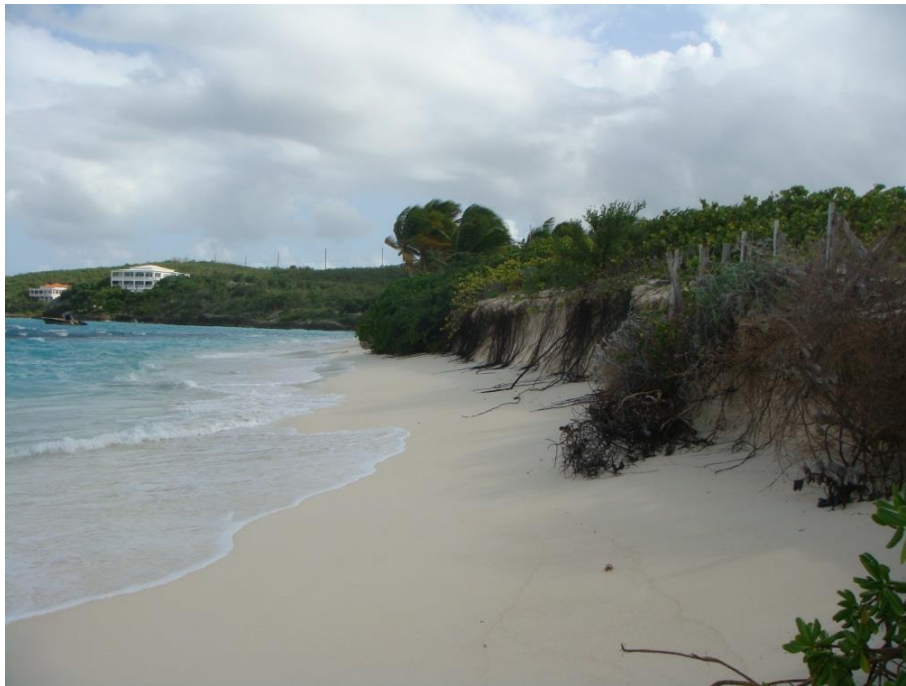
Plate 12 Looking south down Upper Shoal Bay East at BM31 (Masons Fence) in December 2009 a year or so following the beginning of severe erosion in the area (refer to plate 16 for historical record). Photograph courtesy of S. Wynne.

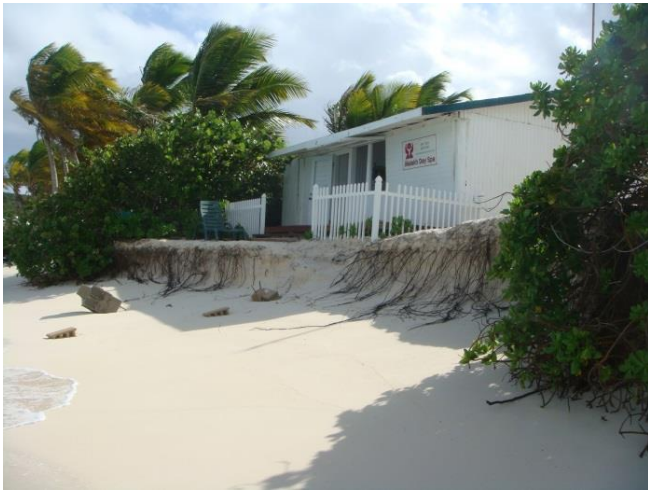
Plate 13 (left) Status of erosion between BM30 and BM31 on 15th December 2009 at Upper Shoal Bay East following the onset of severe erosion seemingly punctuated by Hurricane Omar in 2008. Photograph courtesy of S. Wynne.

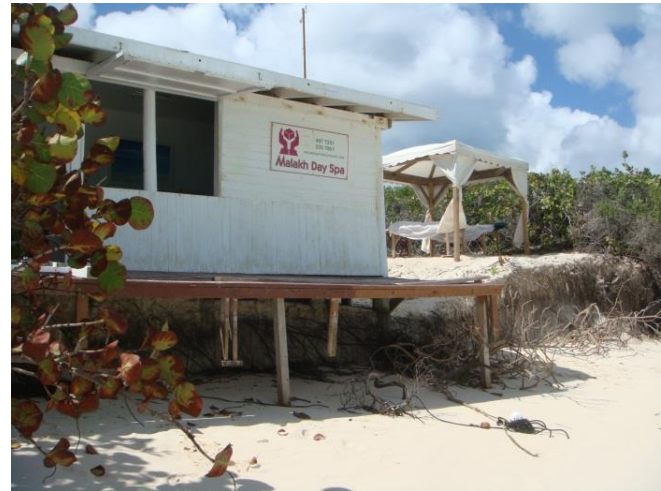
Plate 14 (right) Status of erosion between BM30 and BM31 on 15th February 2010 at Upper Shoal Bay East. The amount of beach material lost here during the two month period since Plate 13 was extremely concerning. Photograph courtesy of S. Wynne.

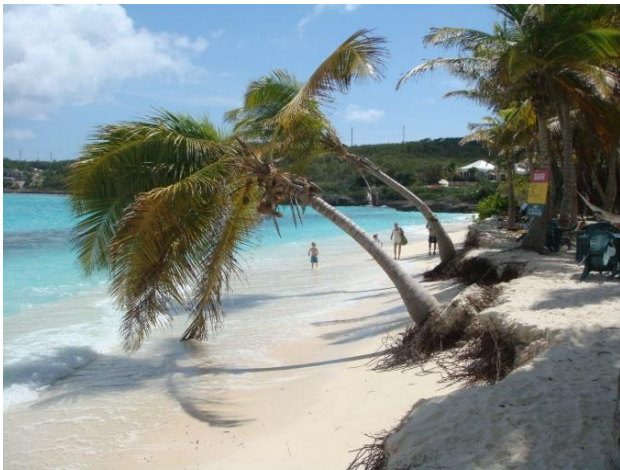
Plate 15 (left) Beach erosion at Gwens Reggae Bar, Upper Shoal Bay East, leading to the loss of numerous old coconut palms in February 2010. Photograph courtesy of S. Wynne.

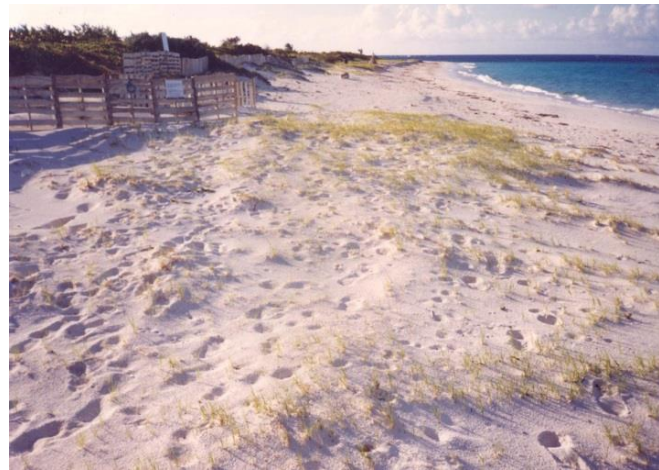
Plate 16 (right) Taking a step back in time to the early 1990's when concerns were first raised about erosion at Upper Shoal Bay East, inspiring the construction of a pallet 'sand trap' fence. This fence was subsequently destroyed by weather conditions, but the image is a good historical reference for Plate 12 (Masons Fence). Although both images are looking in different directions they depict the same stretch of coast, also partially including that in Plates 13 & 14. Photograph would have been taken from the rough location pictured in Plate 15, and is courtesy of DFMR archives.

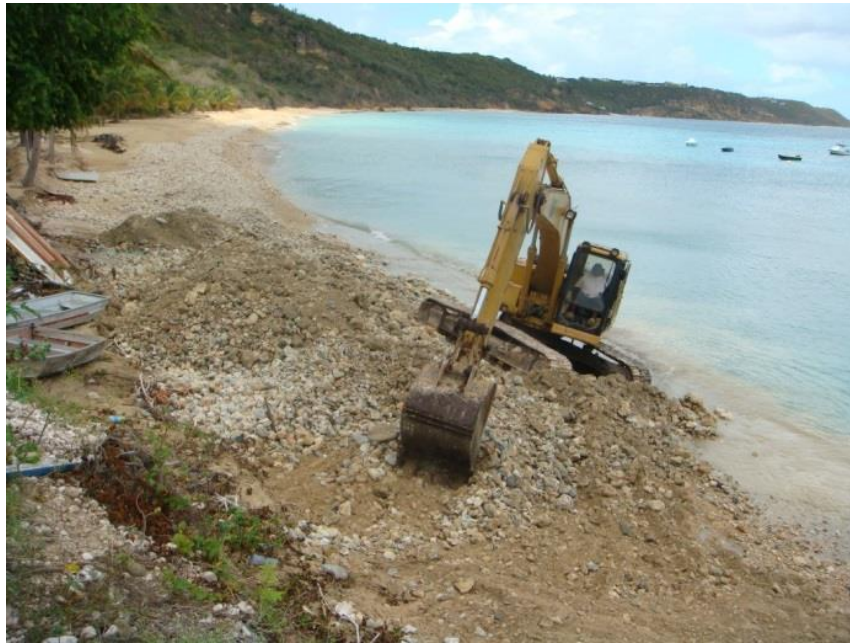
Plate 17 (left) Removal of stones at Crocus Bay uncovered by strong ground swells in early 2008. This material would have formed an important foundation for the beach here and a great defence against such sea conditions. Material was sold as aggregate. Photograph courtesy of DFMR archives.

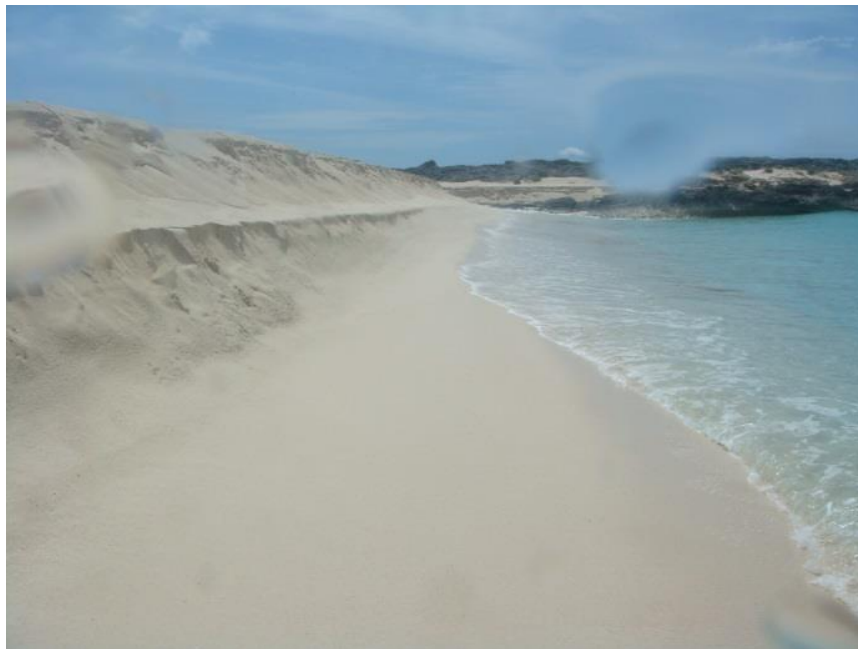
Plate 18 (right) Tall wave cut sand cliff at Dog Island in October 2009. Such features are often present here during periods of strong ground swells. Photograph courtesy of S. Wynne.

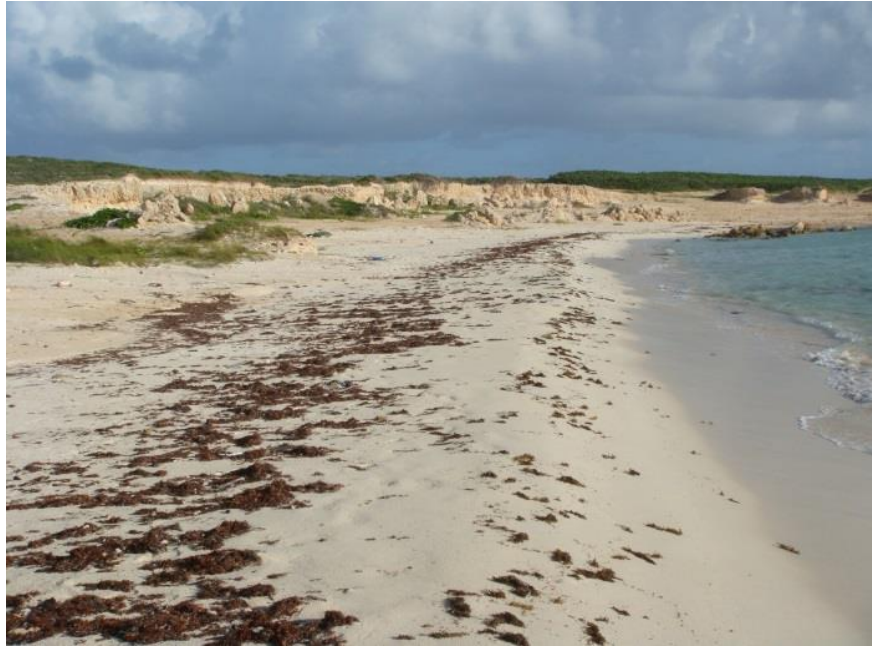
Plate 19 (left) Loss of beach at Windward Point Bay following a number of years of sand mining in the area. Photograph courtesy of DFMR archives.

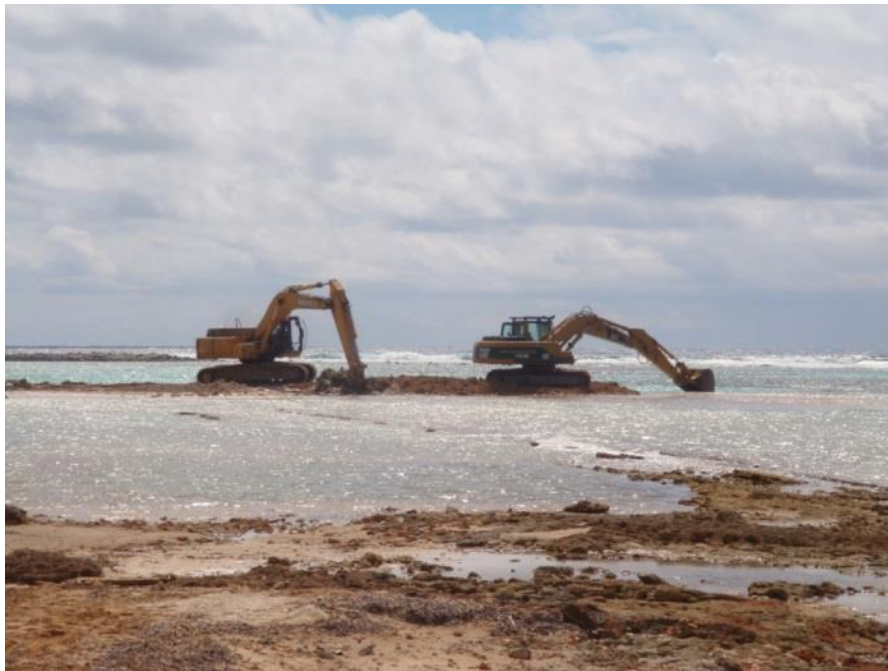
Plate 20 (right) Digging sand from within Forest Bay in April 2008 as an attempt to create a beach to convince investors for the potential of a new coastal resort development. Photograph courtesy of DFMR archives.
