Anguilla Marine Water Sampling Pilot Study 2008

Department of Fisheries and Marine Resources

Part of the Anguilla Marine Monitoring Programme

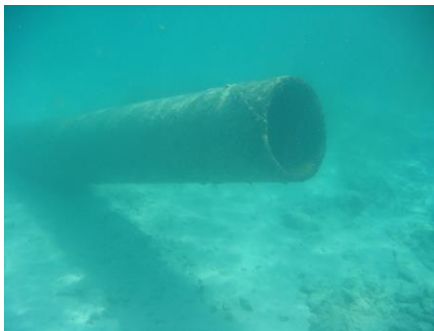
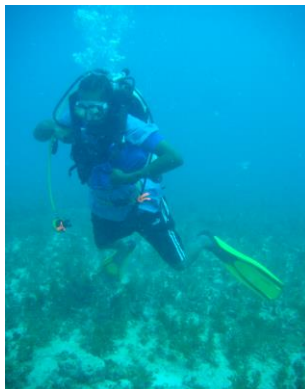
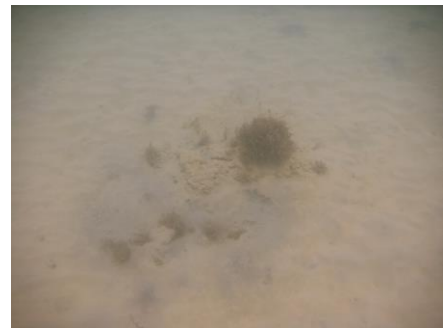
Plates 1 to 3 – The pipe connecting Merrywing salt pond to Cove Bay; Collecting deep water samples in the St Martin Channel; Dark anoxic sediment in shallow water near Pelican Point (suggesting high organic content).

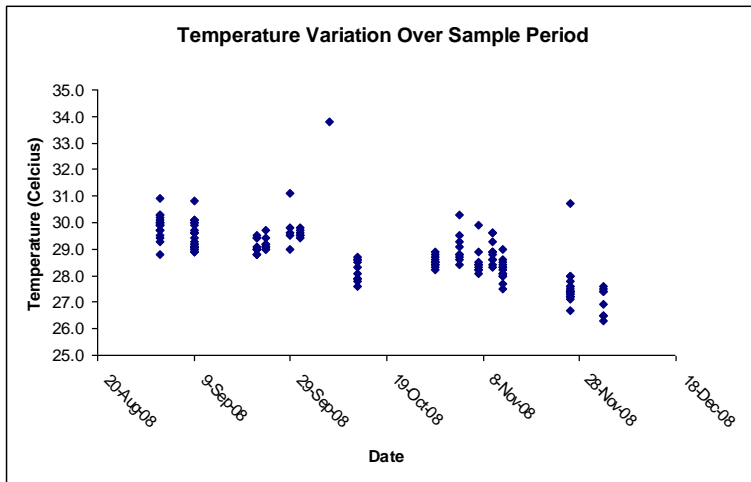
Figure 1 – Temperature trend through the study period. Note the interesting dip two days before hurricane Omar made landfall. Points noticeably above groups were from pond or inlet pipe samples. Graph does not include data collected the week directly after hurricane Omar.

sites. The temperature variations over the whole study period are showing in figure 1, which will be discussed in more detail in section 4.

One interesting anomaly in the data are lower than normal temperatures noted on the 13th October, two days before Omar made landfall. Here temperatures dropped by approximately 1.5°C from those recorded previously. This is a phenomenon not reported in the literature and could be an important aspect of a hurricane's impact on water masses immediately prior to passing.

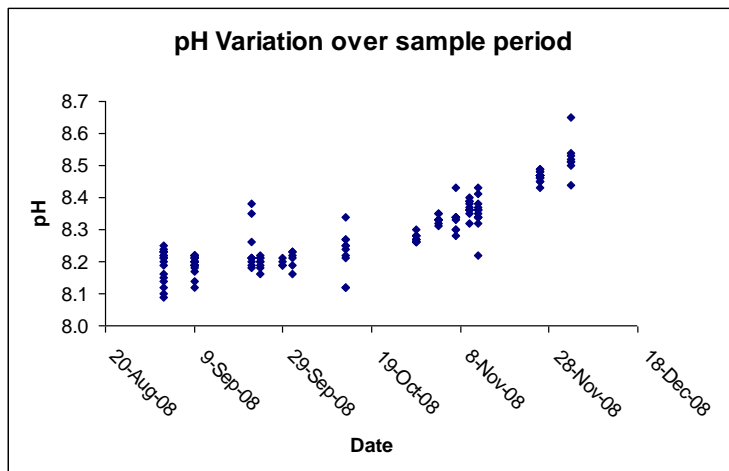
Figure 2 – Trend in pH through the study period. Note the inverse relationship that seems to be occurring with temperature (see figure 1), a relationship that is demonstrated further in figure 3. Graph does not include data collected the week directly after hurricane Omar.
