Anguilla Fisheries and Marine Resources Research Bulletin

The Anguilla Beach Monitoring Program Report 1992-2014: Temporal analysis of twenty two years of monitoring data

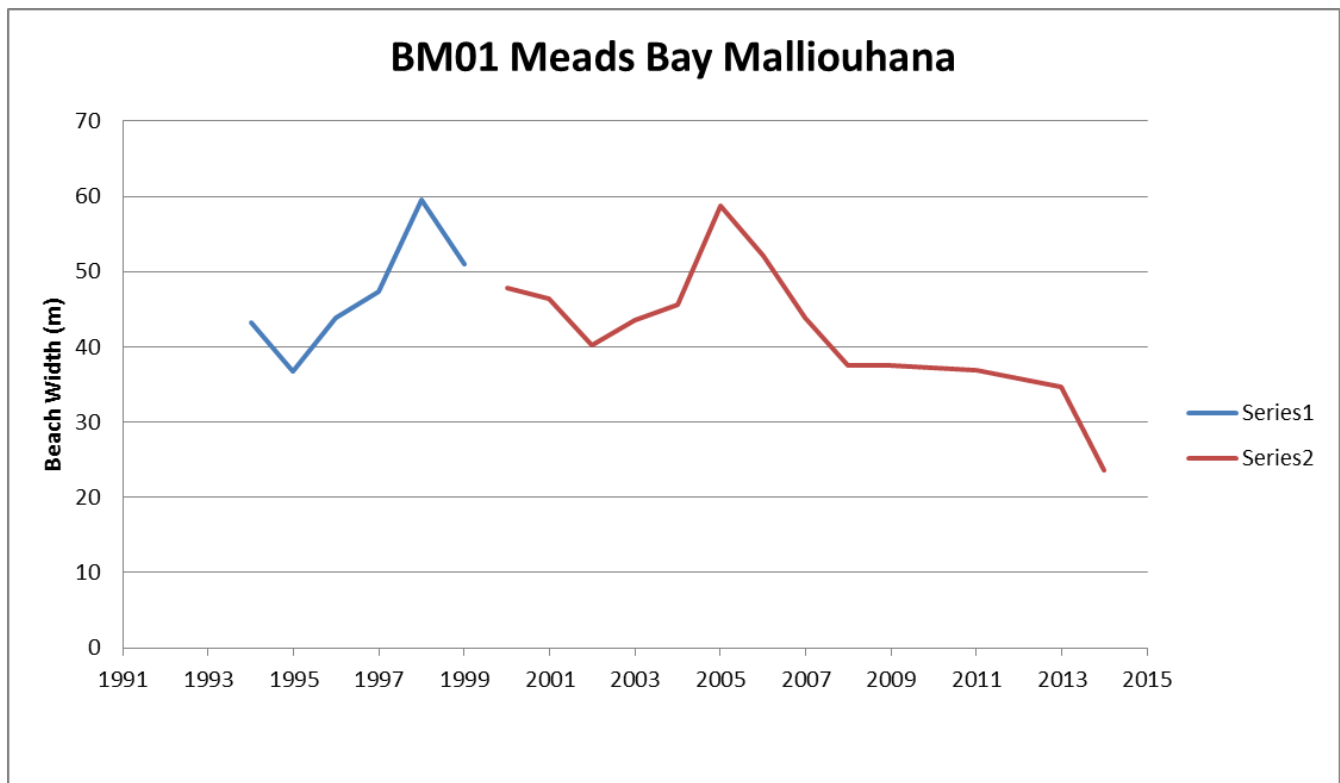
Over the study period of 21 years, Meads Bay, one of the most important tourist beaches on Anguilla, has suffered an average beach width loss of 16 m per profile location (0.94 m/yr^{-1}), the second most severe of all beaches monitored. Figure 5 presents mean annual data for one of the three monitoring locations on this beach. The graph clearly shows the loss of beach width following Hurricane Luis in 1995 and subsequent accretion until Hurricane Lenny in 1999 that also caused the loss of the original reference point. After re-establishing the reference point erosion continued until 2002, after which beach material began to be re-deposited back. In 2006 erosion continued again through Hurricane Omar in 2008 and on into 2014. This example illustrates the natural ability for this beach to rejuvenate itself following hurricane damage, at least to some extent, recognizing that recovery has yet to take place following the last event, almost a decade ago.

Figure 5: Mean annual beach width for the monitoring location at the eastern end Meads Bay. Data has been split to identify where a change in reference point happened following Hurricane Lenny

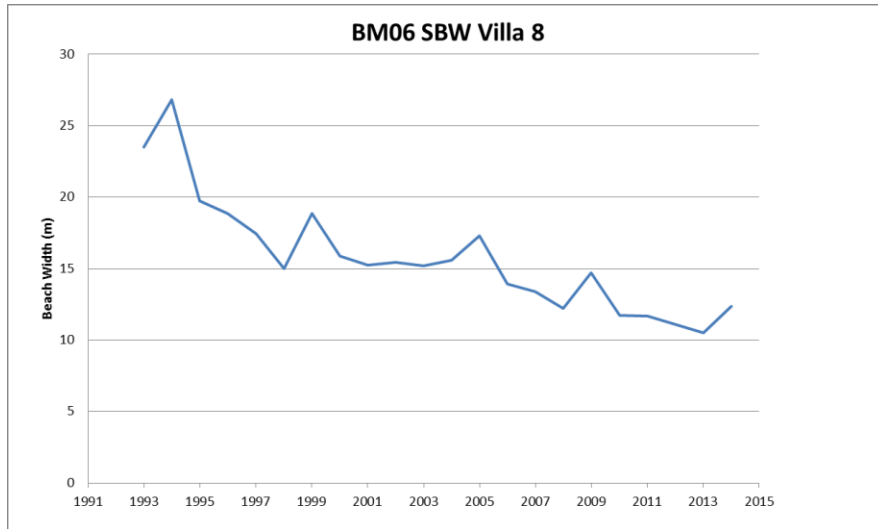
The beach at Shoal Bay West is among those in Anguilla that is relatively well known for erosional processes over recent decades. This local knowledge is backed up by the graphs presented in Figures 6 & 7 which illustrate a gradual loss of beach material. Similar trends are present along all four profile locations. Although hurricanes have caused considerable damage here (Plates 3-5) their effect is somewhat camouflaged by the background erosional regime present, with Hurricane Omar in 2008 appearing to have very little influence. With this being said, Figure 7 does however show periods of increased losses following Hurricane Luis in 1995, Hurricane Lenny in 1999 and Hurricane Earl in 2010.

Figure 6: Mean annual beach width for the western end of Shoal Bay West

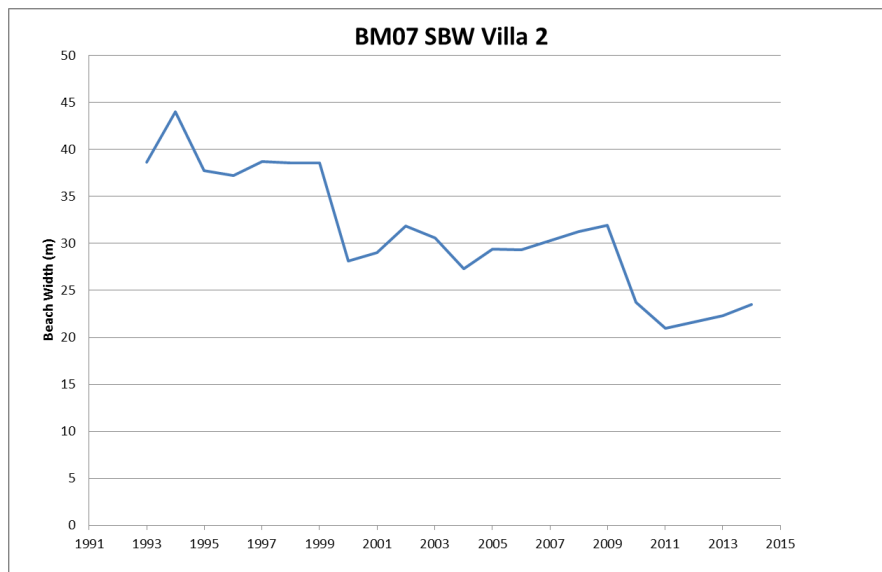
Figure 7: Mean annual beach width for the mid-western end of Shoal Bay West

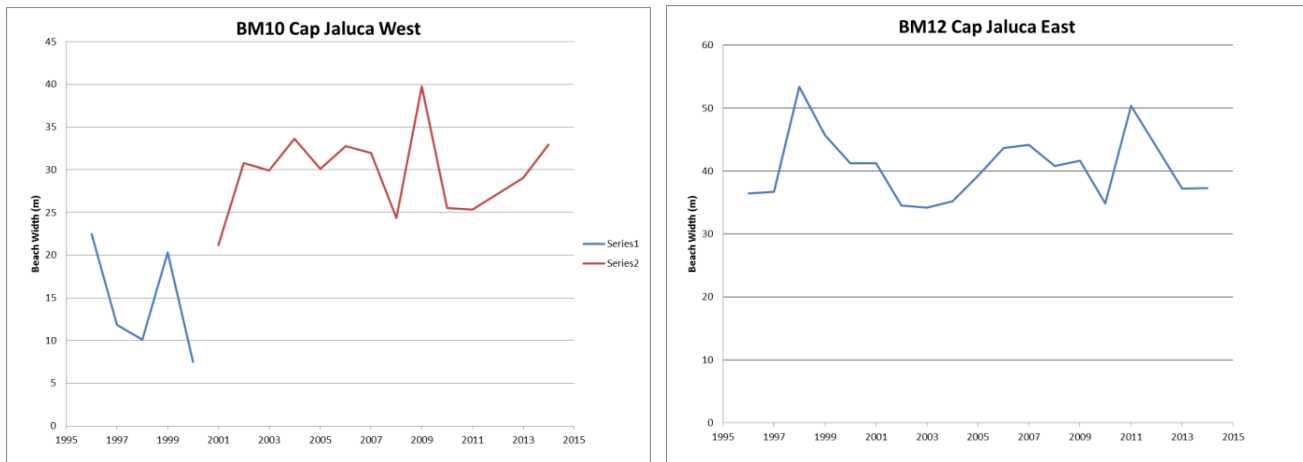
This beach has undergone significant beach nourishment programs by the management of Cap Juluca Hotel, following damage by hurricanes (Plate 7). This is illustrated in Figure 8, which also depicts the difference in regime that occurs on the western end of the beach compared with that on the eastern end. Reports and photographic evidence shows significant damage here following Hurricane Luis in 1995, although beach monitoring did not start here until after this event. In the western end, erosion continued after this storm, which led to the first beach nourishment. Sand was dredged from offshore and put along the shore line, combined with rebuilding and replanting the dune slope to increase the hotels aesthetic appearance. Between November 1995 and February 1996 a total of 40,000 cubic yards of sand were dredged from the bay and placed on the beach (Cambers, pers. comm.). In 1998 Hurricane Georges submerged the whole beach and a further 30,000 cubic yards of sand were dredged from the bay and placed on shore. This material was again lost when Hurricane Lenny hit in 1999, causing massive erosion leading to the undermining of the villa developments and many of their villa stair cases left as ‘islands’ unconnected to the buildings (Plate 6). Further beach nourishment, the construction of a major vertical sea wall in front of the villas, and replanting of vegetation restored the area by September 2000, and led to a period of relative stability until Hurricane Omar in 2008. Once again beach nourishment, this time via sand from Barbuda as well as offshore dredging, replenished the beach until Hurricane Earl in 2010 removed it again. Although these events can also be seen in the eastern profile, changes there were less severe and stability more prevalent. The evidence over the past 20 years indicates that although the beach can be restored via costly beach nourishment measures and a level of stability achieved, this is only a temporary solution until the next hurricane arrives.

Figure 8: Mean annual beach width for the western end of Maundays Bay (BM10) and the eastern end of Maundays Bay (BM12). Over the illustrated period, despite beach nourishment, the western end has lost a total of 3.2 m in beach width (-0.2 m/yr^{-1}) whereas the eastern end has gained 0.9 m (0.05 m/yr^{-1}). This, combined with the third profile location gives an overall mean beach width increase of 1.3 m, or an accretion rate of 0.27 m/yr^{-1} .

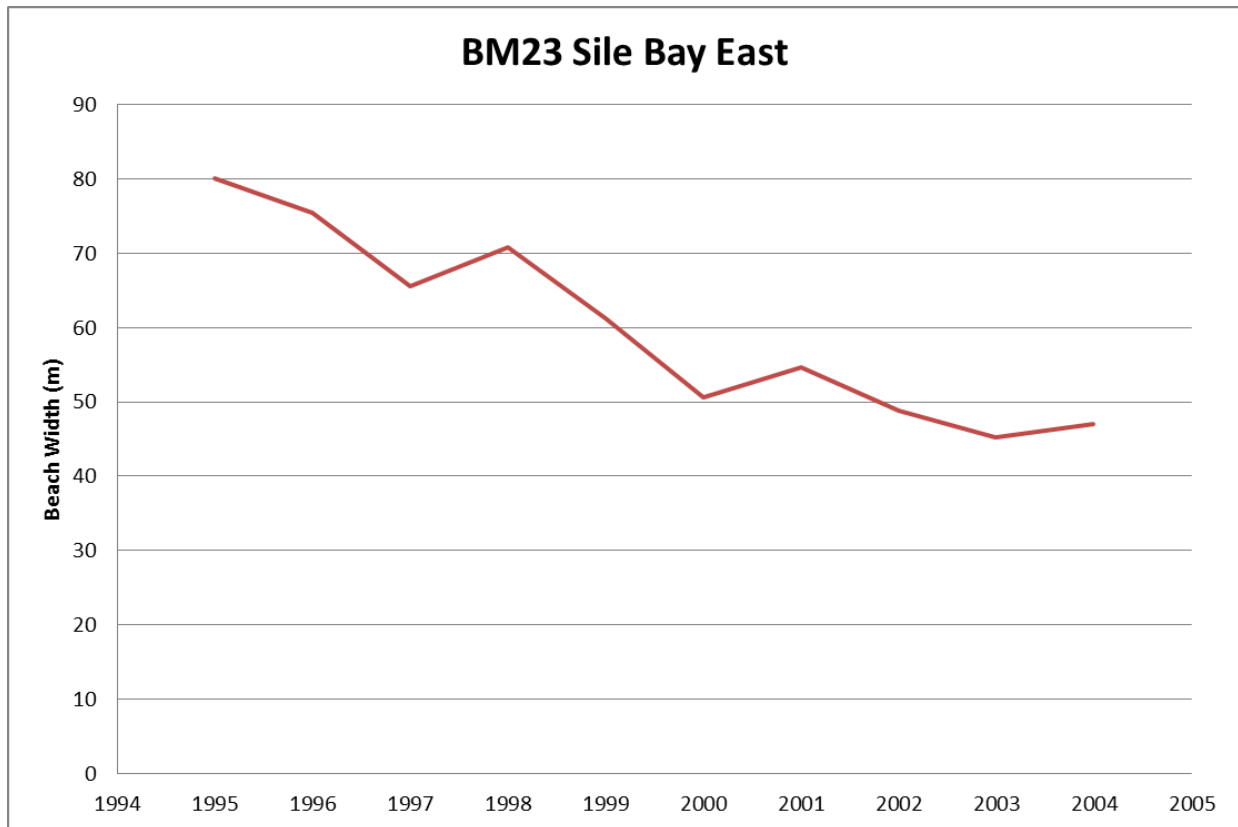
On the south eastern coast of Anguilla, the loss of Sile Bay beach is the best illustration provided by this study as to the adverse effects of sand mining and the removal of dune systems. Back in the 1980's there were reportedly large sand dunes present here that were removed as aggregate for the construction industry. The subsequent beach loss that was observed is probably a contributing factor for the beginning of the beach profiling program in Anguilla, and the reason for a small retaining wall that was built in the area (Plates 9 & 10). This wall however, designed to retain the small amount of sand remaining behind and 'catch' any sand washed up over it, appeared to have the opposite effect as now no sand remains behind it. This all took place before monitoring began, and a profile location set up to include the retaining wall, as well as one a short distance along the coast. The profile at the retaining wall showed a few minimal fluctuations, likely due to inherent variations in measuring coastal features, but the one further along the beach clearly illustrates a long-term degradation (Figure 9). It shows how the removal of material from one area can affect that in other close by areas over subsequent years, a process that is due to the lack of beach material storage provided by a neighboring dune system. Without the dunes providing this back up the natural balance is lost when storm or other erosional events occur. Although not part of the beach monitoring program, as mentioned earlier a similar situation is still currently occurring at Windward Point Bay, where the removal of larger quantities of beach material from the back of the bay has resulted in a significant loss of beach width over the years.

Figure 9: Mean annual beach width for the eastern end of Sile Bay. This profile location exhibits the second greatest overall loss of any within this study, undergoing a beach width reduction of 33 m during the nine year period illustrated.

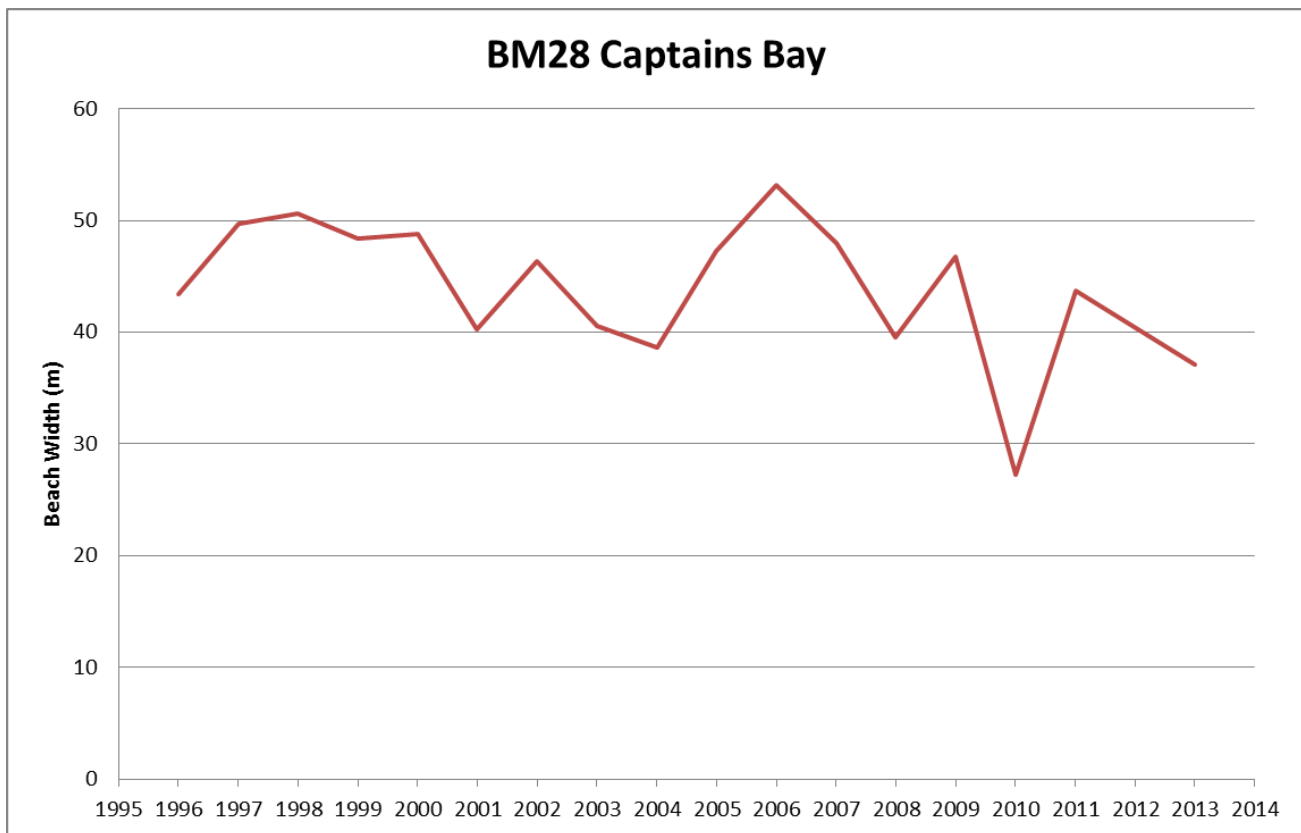
The monitoring site at Captains Bay was originally set up in 1992 as a control site due to the lack of coastal development behind it (some development on the low rocky cliff, but nothing that would affect sand movements). The changes in beach profile noted here appear highly seasonal and also change from year to year as if pulses of sand arrive on the beach periodically that are later washed back out into the bay, sometimes exposing underlying rocks (Plate 11). There are often very large swells and seasonally powerful ground seas that would be responsible for this. Over the 18-year study period a 2 m loss in beach width (-0.11 m/yr^{-1}) has been recorded (Table 2), although a change in reference point following Hurricane Luis in 1995 means data are most comparable between 1996 and 2013, with Figure 10 illustrating a loss of 6.4 m during this time. Surprisingly, despite being renowned for powerful seas, Captains Bay seems less affected by hurricanes than one might expect, although Hurricane Omar (2008) and Hurricane Earl (2010) had a noticeable effect, as they did elsewhere in Anguilla (Figure 4). Indeed, these two storm events are clearly visible in the profile data, and appear to be the main events responsible for the overall loss in beach width during this period.

Figure 10: Mean annual beach width for Captains Bay between 1996 and 2013 with the effect of Hurricane Omar in 2008 and Hurricane Earl in 2010. Other erosion events do not appear related to hurricanes and are likely due to inter-annual seasonal ground sea variations.

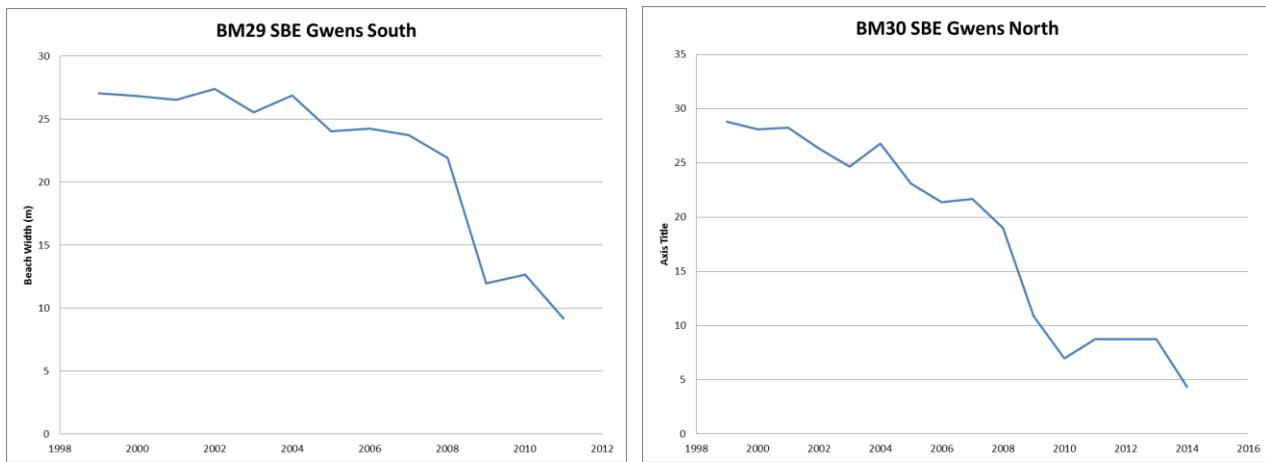
One of Anguilla’s longest beaches, Shoal Bay East is where greatest erosional concern has been focused over recent years (Plates 12-16). When this monitoring program started here in 1992 the beach regime appear stable and the area was known for its expansive and white sandy beaches. In the late 1990’s two extra points were established towards the end of ‘Upper’ Shoal Bay East, presumably due to concerns over erosion there. Indeed, right from the beginning these two sites exhibited erosion, with sporadic accretion from time to time (Figure 11). Then, following Hurricane Omar in 2008 this erosion increased and ultimately ended up with the loss of this entire end of the beach. Gwens Reggae Bar, a locally owned restaurant that operated in the area, and built set back from the beach, had to be relocated to Lower Shoal Bay East in 2014.

Figure 11: Mean annual beach width for the two easternmost Upper Shoal Bay East profile points between 1999 and 2011/2014 respectively. During these periods BM29 lost a total of 17.9 m in beach width (-1.49 m/yr^{-1}) and BM30 lost a total of 24.5 m in beach width (-1.75 m/yr^{-1}).

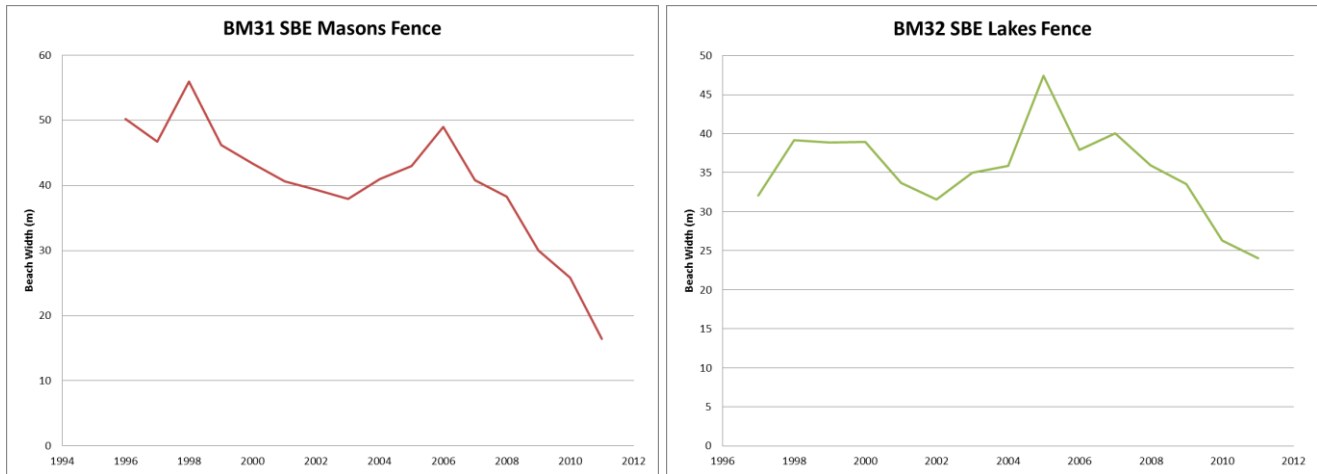
Similar patterns were being seen at other locations moving westwards along the Bay. The profile location known as ‘Masons Fence’ (BM31), also situated in Upper Shoal Bay East began losing material at around the same time, although again punctuated with periods of accretion (Figure 12). Once again this erosion increased noticeably around 2008. Here individual profiles (not illustrated) show the dune slope as a vertical cliff that is being steadily cut back. Past Shoal Point on the eastern end of Lower Shoal Bay East erosion initially remained more gradual until Hurricane Omar in 2008 again began a period of increased erosion at the profile location known as ‘Lakes Fence’ (BM32). To date, erosion has not moved noticeably beyond this end of the beach with profile points further to the western end of the beach still accreting overall or at least remaining relatively stable (Figure 13). However, this story of change is not yet over, and the sea continues to encroach inland in the eastern areas. This is especially concerning as, at the time of writing, a small salt pond within Shoal Point might soon breach, and if this occurs it may exponentially increase erosion in the area. Furthermore, although not included here as a figure, the profile immediately west of ‘Lakes Fence’ known as ‘Elodius’ (BM33) has also begun to exhibit an overall loss since 2001, again with a noticeable event in 2008 following Hurricane Omar, and as of 2014 had retreated by a total of 5 m.

Figure 12: mean annual beach width for the two profile locations immediately westward of those depicted in the previous figure 11. The profile location at Masons Fence has exhibited the greatest total loss during the study period of 47.6 m (although the graph above only illustrates 33.8 m of this). The delay in erosional onset beyond Shoal Point is illustrated by BM32 where relative stability is apparent until Hurricane Omar in 2008.

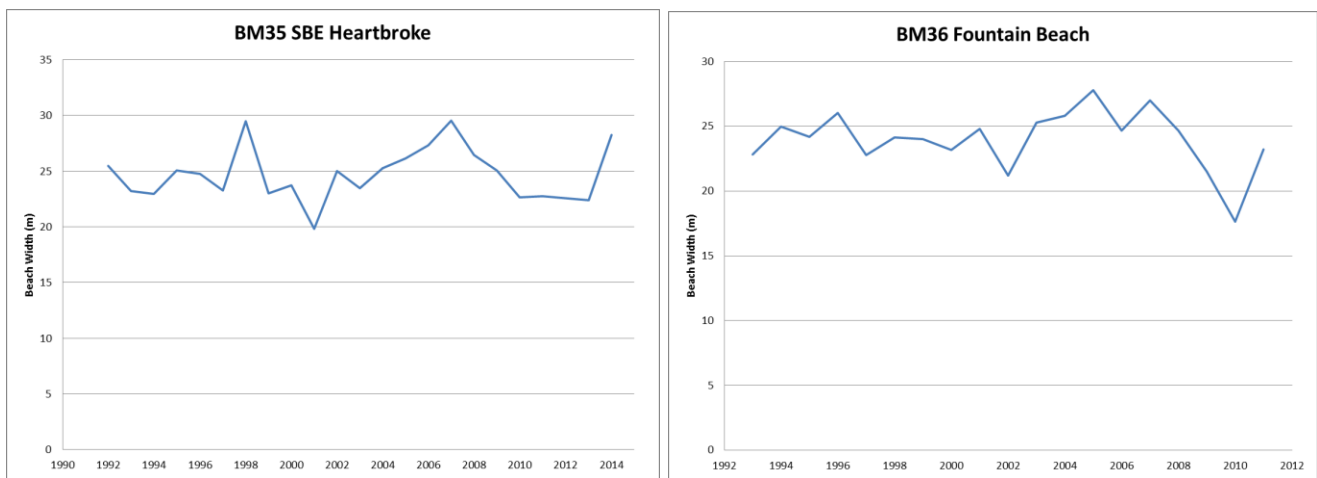
Figure 13: Mean annual beach width for the two profile locations at the western end of Lower Shoal Bay East illustrating the more stable erosional regimes still in effect there. Noticeable loss of material did take place during Hurricane Omar and Hurricane Earl, but the beaches seem to be recovering back to previous levels.

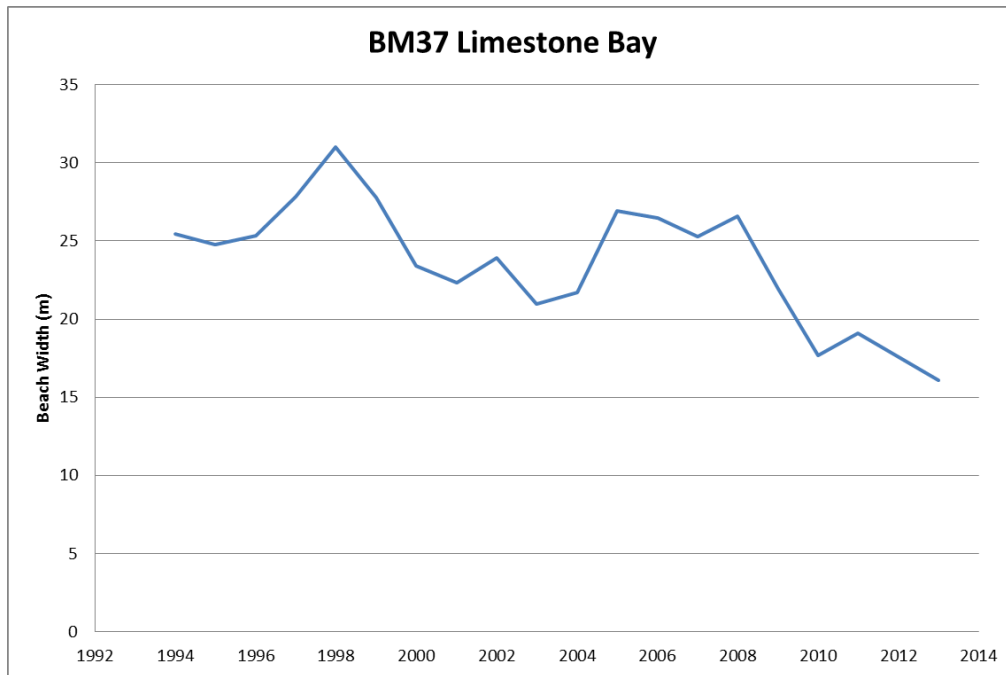
In a similar way to Captains Bay described earlier, the beach at Limestone Bay exhibits more seasonal changes not always linked to major hurricanes. Beach material can also change seasonally, with sand at certain times of year and stones at others. Having said this, there has been a gradual decline in beach width that appears punctuated by two of the major hurricane events: Lenny in 1999 and Omar in 2008 (Figure 14). A lack of recovery since these events appear to be what is behind this overall 9.3 m loss of beach width over the 18 year study period here.

Figure 14: Mean annual beach width for the monitoring location at Limestone Bay between 1994 and 2013 illustrating an overall loss in beach width of 9.3 m.

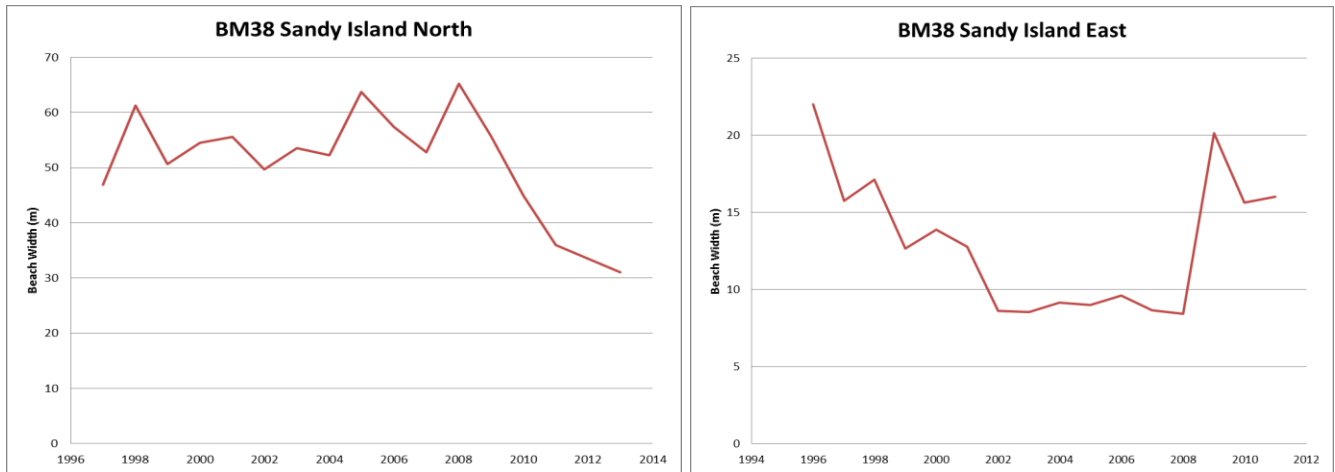
The low lying nature of Sandy Island means it is often inundated during hurricane events. In 1995 for example, during the second year of monitoring, Hurricane Luis reportedly submerged the cay and the beach disappeared. The beach quickly returned once the storm subsided, the wooden restaurant was rebuilt and vegetation replanted/regrew. Since then, the erosional regime has been quite mixed across the small cay, with the northern profile relatively stable up to 2008 whereas the eastern one has been through a period of decline (Figure 15), and the western one quite unpredictable (not illustrated). As with many locations around Anguilla, Hurricane Omar in 2008 seems to mark a turning point however with the northern profile’s stability changing to a sudden decline and the eastern decline punctuated with sudden accretion. Such a change suggests the island is currently shifting in a southeasterly direction, although future monitoring will be needed to confirm whether there is an overall loss in beach sand or whether the island is indeed moving its position. Such conclusions will be of critical importance for the understanding of the cay and its future, as the current mean overall loss in beach width per profile location is 12.4 m, quite significant for an island of such a small size.

Figure 15: Mean annual beach width for two of the monitoring locations at Sandy Island illustrating potential south-easterly movement of sand following Hurricane Omar in 2008.

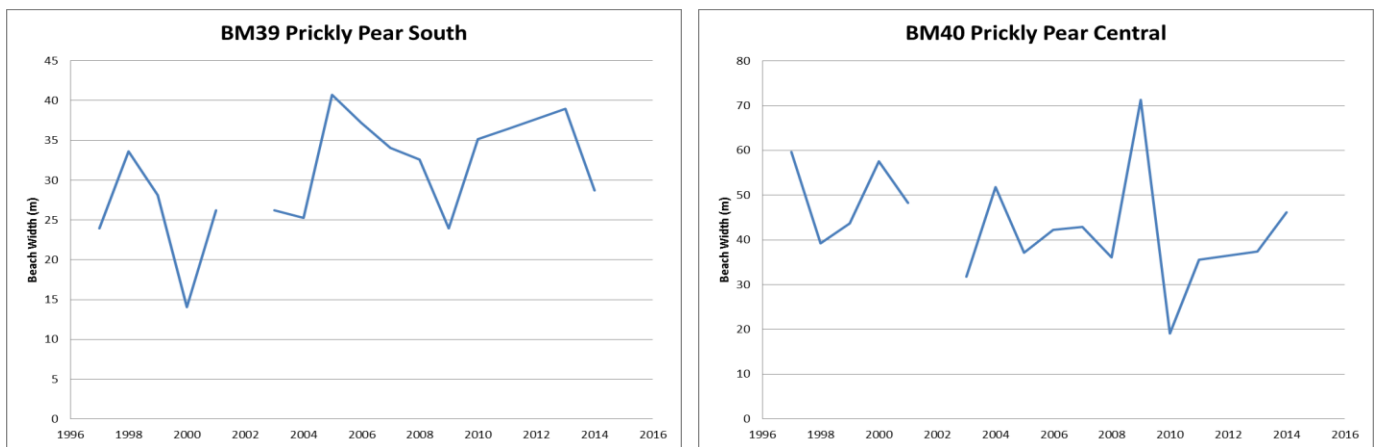
Of the three monitoring locations on Prickly Pear some exhibit very large seasonal changes, with the ‘central’ location (BM40) recording one of the largest single erosional events during the study period, when in 2010 (following Hurricane Earl) it lost 52.3 m in beach width. Similar large seasonal changes can also be seen at the ‘south’ profile location (BM39), although of a lesser magnitude. (Figure 16). Despite their names, these two sites are situated on the relatively exposed northeastern side of Prickly Pear East, and so these changes are not surprising especially considering the strong ground seas that can affect the cays and access to them by boat. This can be corroborated in part by the more sheltered profile location known as ‘Johnnos’ (BM41) that has remained relatively stable aside from a notable though less dramatic erosion event again following Hurricane Earl in 2010 (Figure 17). Prior to this event, across the 12 year study period BM41 had a total increase in overall beach width of 6.4 m, but the two years after Hurricane Earl, there was a loss of 27m. The results at Prickly Pear East, where despite large losses BM39 is currently overall 4.8 m wider than when the study period commenced, suggest a shift in beach material as well as an overall loss, where sand is shifting towards the southeast.

Figure 16: Mean annual beach width for the two south and eastern (central) monitoring locations on Prickly Pear East illustrating large seasonal changes not clearly linked to Hurricanes. Having said this erosion at BM39 potentially follows Hurricane Lenny in 1999 and a very large loss at BM40 follows Hurricane Earl in 2010.

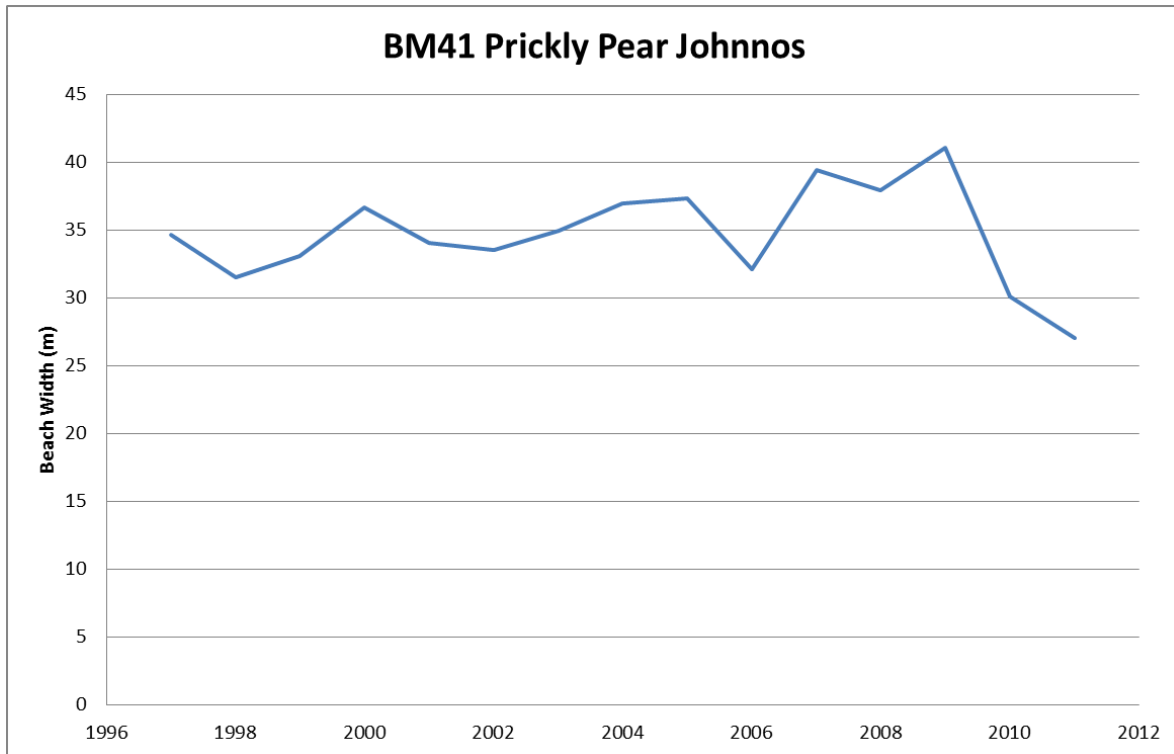
Figure 17: Mean annual beach width of the more sheltered northern monitoring location showing overall stability in beach width until Hurricane Omar in 2010. (It is however possible that subsequent ground swells will once again redeposit material here).
